UPPER HUDSON RIVER WATERSHED  
SACANDAGA RIVER BASIN

**LAKE ALGONQUIN DAM**  
**HAMILTON COUNTY, NEW YORK**  
APPROVED FOR PUBLIC RELEASE;  
DISTRIBUTION UNLIMITED  
CONTRACT NO. DACW 51-78-C-0035

**PHASE I INSPECTION REPORT**  
**NATIONAL DAM SAFETY PROGRAM**

Prepared by  
CONVERSE WARD DAVIS DIXON  
CONSULTING ENGINEERS  
91 ROSELAND AVENUE, P.O. BOX 91  
CALDWELL, NEW JERSEY 07006

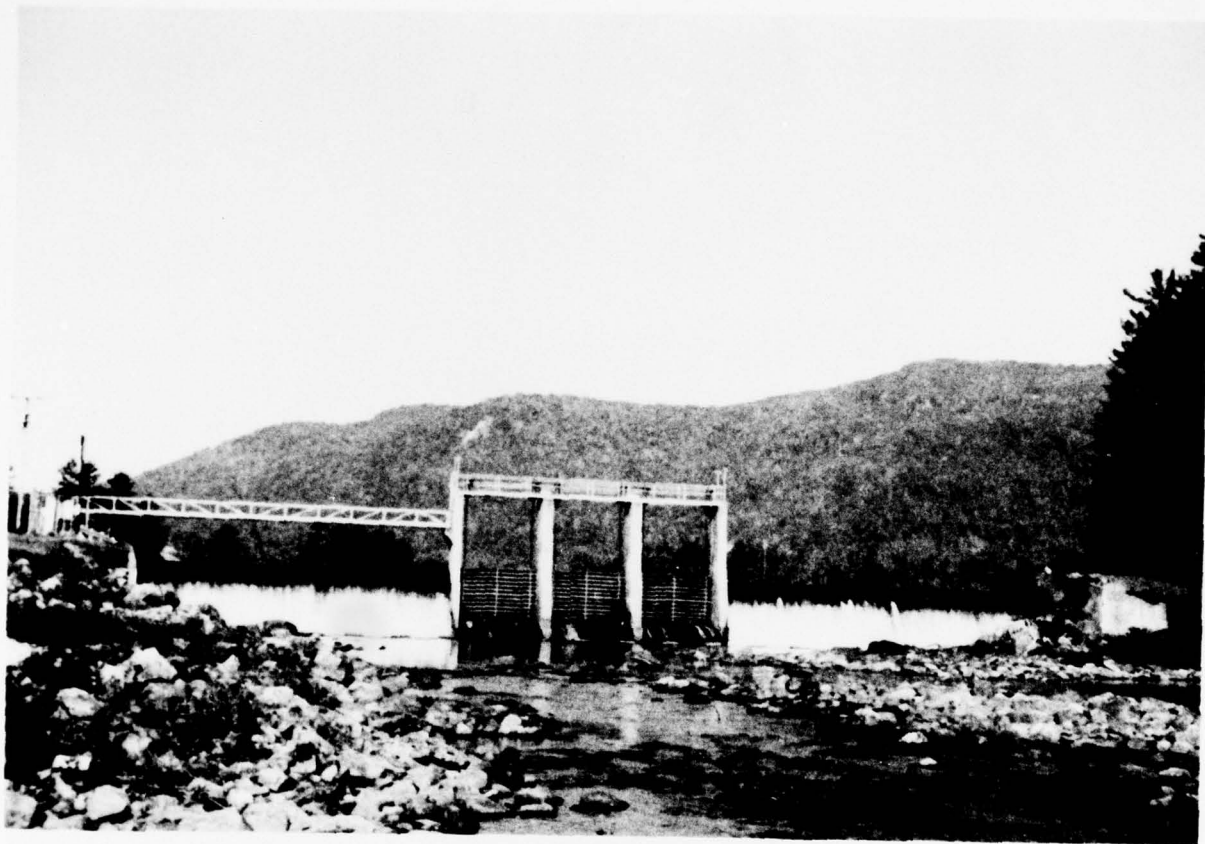
OVERVIEW-LAKE ALGONQUIN DAM

At the start of the inspection, all three gates were shut. A slight amount of leakage was noted coming from beneath each gate. (See Overview Photo.) On the day of the inspection, the right gate was inoperable because the lift motor was down for repairs. The middle gate was raised about  $1\frac{1}{4}$  inches in 15 minutes from a switch in the control panel at the right abutment area (Refer to Section 1.2h and Fig. 1, Appendix D). The left gate was raised a total of about 4 feet in approximately 45 minutes by an operator with a portable electric motor (Fig. 2, Appendix D). This was done in order to lower the lake level below spillway crest elevation so that the downstream face of the spillway could be inspected. The left and middle gates and gate controls functioned satisfactorily and, except for some rust on the lift arms, they appeared to be in good condition and generally well maintained.

4. Repairs to the inoperative gate should be completed as soon as possible, certainly before the end of this year.
5. An emergency warning system should be formulated and officially presented to local police authorities as soon as possible, preferably within one calendar year.

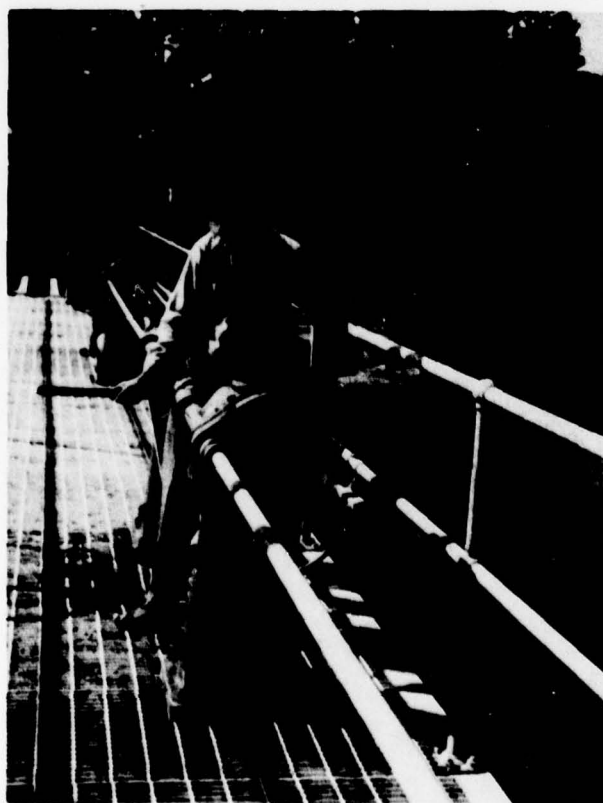
The steel frame and grates of the gate control platform atop the gate structure piers, and the steel truss access walkway over the right spillway section, appeared to be in generally good condition (Figs. 2 and 20, Appendix D). The walkway from the left abutment to pier 4, as shown on the design drawings (Plate III), was never built, although the foundations are in place.

FIGURE 2      RAISING OF LEFT GATE

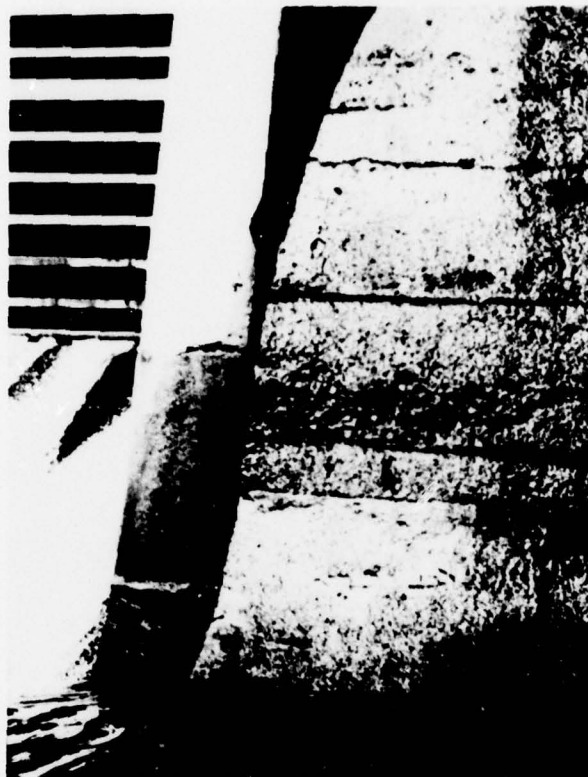
The gravity/spillway sections of the dam appeared to be in generally good condition, with only minor erosion on the crest and downstream faces (Figs. 3, 4 and 5, Appendix D). Some moderate structural cracking was noticed on the downstream face of the right monolith of the left gravity/spillway section near its junction with pier 4 (Figs. 4 and 5, Appendix D). No leakage was observed coming through the cracks. A large spall was observed on the crest of the right gravity/spillway section at its junction with the pier 1 key (Fig. 6, Appendix D).

FIGURE 5      CRACKS IN LEFT GRAVITY/SPILLWAY SECTION  
NEAR PIER 4

2. Appropriate steps should be taken to stop or control seepage through the earthen fill at the left abutment.
3. All cracked, spalled and deteriorated concrete on the left abutment retaining walls, and elsewhere on the gravity/spillway and gate/sluiceway structure and right abutment should be repaired.

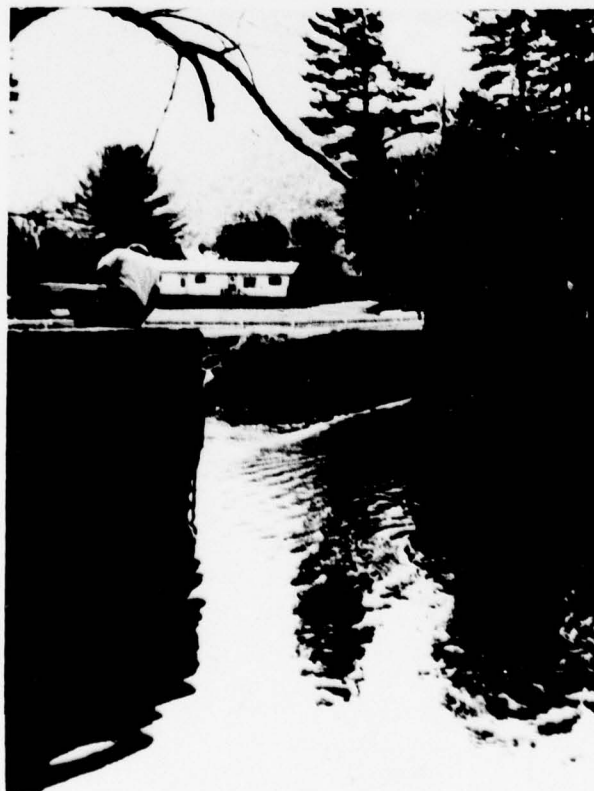
The left abutment appeared to be in generally poor condition. The upstream wingwall (perpendicular to direction of flow) had a vertical crack that extended transversely over the top of the wall. There was a slight displacement of the wall upstream. The edge of the wingwall was badly cracked and spalled, and a reinforcing bar was clearly exposed (Fig. 10, Appendix D). The left abutment sidewall (parallel to direction of flow) was moderately eroded at and below the spillway water line. There were large areas that had apparently been patched recently. Seepage was occurring from a large spall about 5 feet downstream of the gravity/spillway joint and approximately 2/3 of the way from the top (Figs. 11 and 12, Appendix D). There was also a large spall at the junction of the sidewall and downstream wingwall near the base (Figs. 11 and 13, Appendix D). Water was seeping through the spall, and reinforcing steel was clearly visible. The concrete at the base of the sidewall was moderately eroded below the water line.

FIGURE 10      FEATURES OF LEFT UPSTREAM WINGWALL

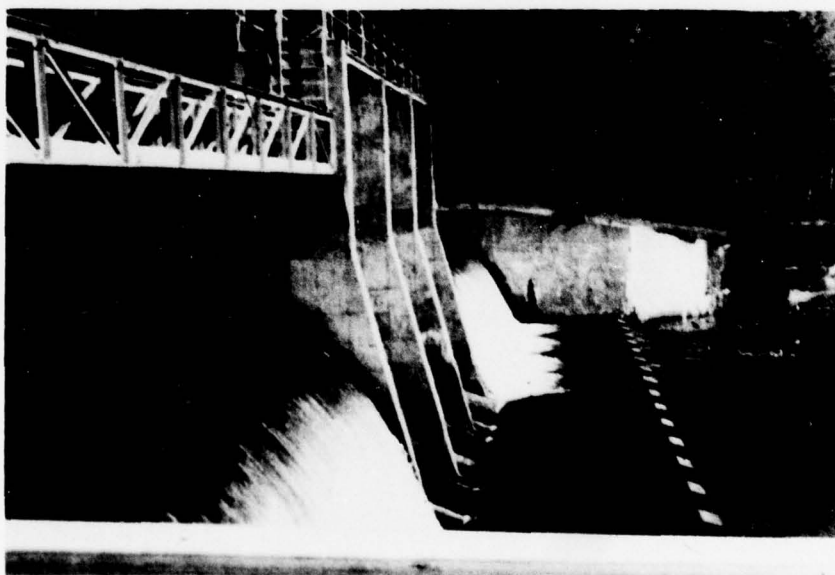
At the start of the inspection, water was flowing over the spillway at a depth of  $3\frac{1}{2}$  to 4 inches. With the opening of the two operable gates, the water level dropped below spillway crest elevation, so the downstream face of the spillway could be inspected and joints checked for leaks. Before the end of the inspection, the gates were closed and water began to flow over the spillway section again.

FIGURE 20 FLOW OVER SPILLWAY AT START OF INSPECTION

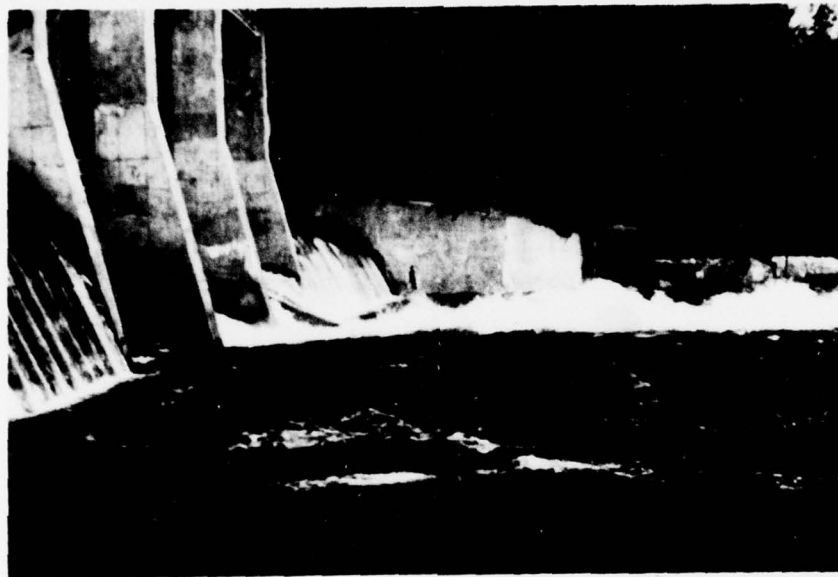
generally good condition, with some minor erosion of surface concrete. Drain weeps were clearly visible and no water was noticed flowing from them. In fact, a small vortex was noticed going into one of the drains of the concrete apron after the gates had been shut and the tailwater had dropped, and before flow had resumed over the spillway. The concrete baffles were very effective in dissipating energy when the gates were opened (Figs. 7 and 21, Appendix D).

FIGURE 21 TAILWATER 30 MINUTES AFTER OPENING OF GATES
